# Property Insurance Captive

# Hall Assessment Program

## Corinthian Masonic Temple Association, Marysville, CA

**Date Visited:** 2/27/2026

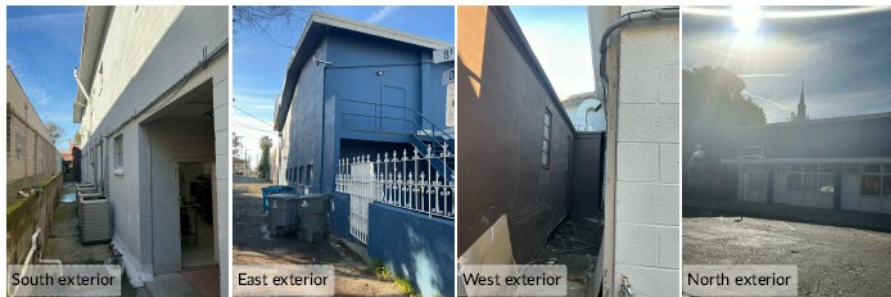
South exterior

East exterior

West exterior

North exterior

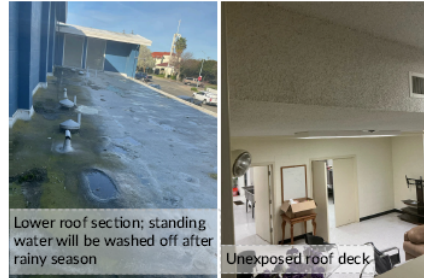
Roof Type	Spray Polyurethane Foam (SPF) Roofing
Roof Deck Type	Wood
Roof Construction Description	Spray-on Foam, supported by wood deck
Roof age	6-10 years
Roof Access Available During Survey	No
Type of Roof Access	Portable ladder
Slope to drain/gutters appropriate as evidence by lack of standing water	No
Adequate roof drain strainers	N/A
Roof clear of debris	Yes

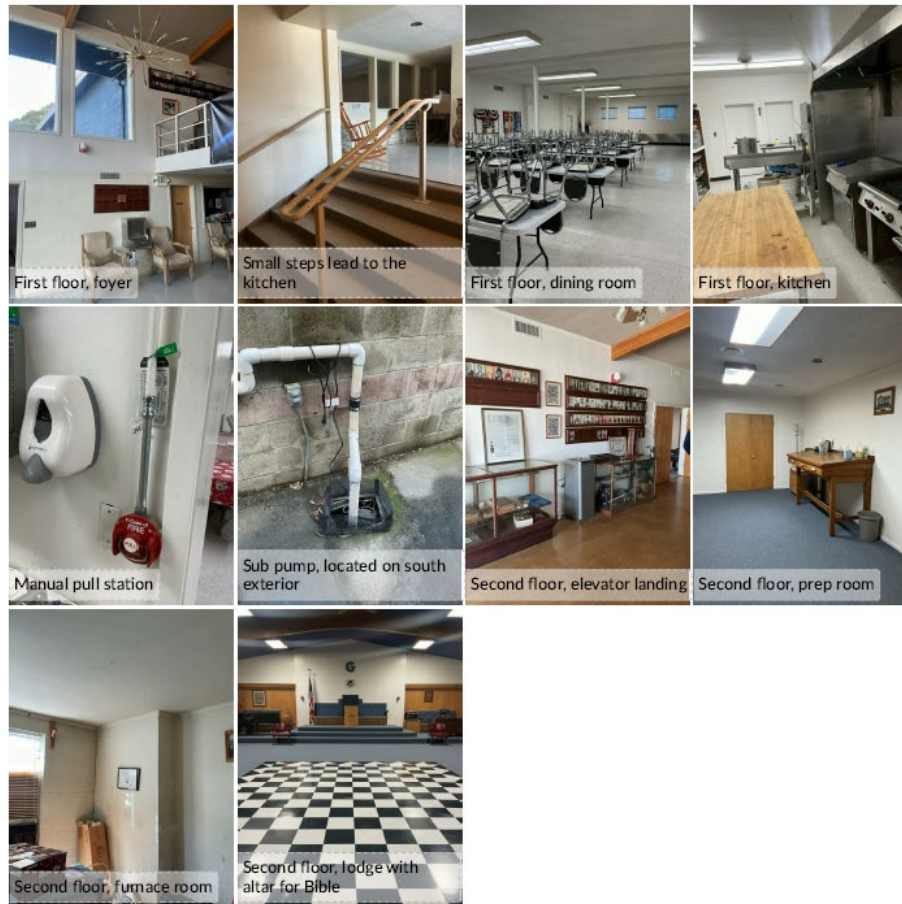
The site is a historic building, originally constructed as a Masonic Lodge. Floor uses include:

- First floor: Documentrix and office tenants, operating during normal business hours. Masonic lodge has dining room, kitchen, and access to the back alley.
- Second floor: Lodge, elevator room, furnace room, and prep room

Some organizations, such as The Eastern Star, DeMolay, and Rainbow Girls, may utilize the lodge spaces. The building is occupied primarily for Masonic events, with occasional private events. There are two stairways: one at the front interior and one at the front exterior.

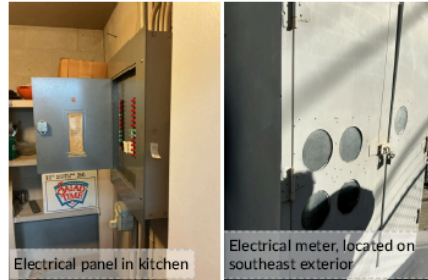
Electrical panel in kitchen

Electrical meter, located on southeast exterior

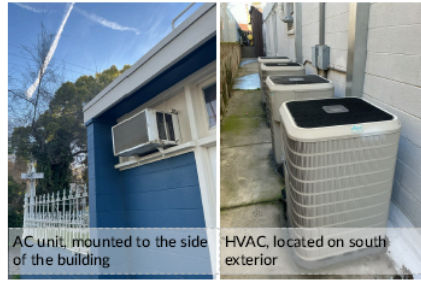
<b>Notes</b>	The building is equipped with four gas-fired furnaces, two located on the first floor and two on the second floor, that operate together as part of the overall HVAC system. All units were installed in 2007, and the second-floor furnaces are currently in the process of being replaced. The air conditioning system has an issue with the evaporator coil.
--------------	---

AC unit, mounted to the side of the building

HVAC, located on south exterior

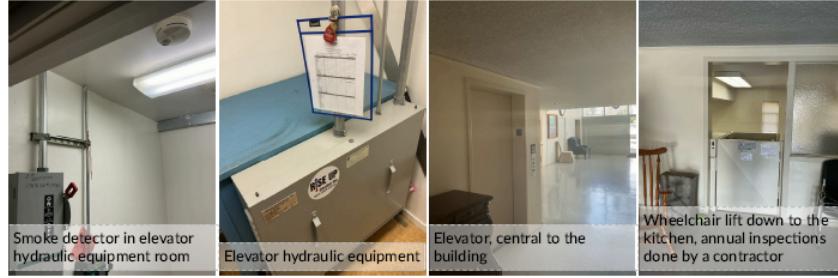
<b>Condition</b>	Average
<b>Does elevator(s) have earthquake safety shut-down device</b>	Unknown
<b>Does elevator(s) have a fire alarm recall device</b>	Yes

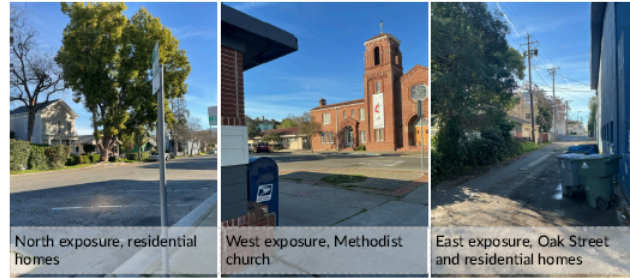
North	Across 8th Street are residential homes.
South	Adjacent is an unidentifiable building, assumed to be a commercial building.
West	Adjacent is an unoccupied building, and across D Street is a Methodist church.
East	Across Oak Street are residential homes.

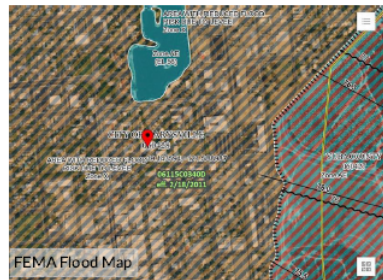
DFIRM ID	06115C
Flood Zone	X
Flood Zone Subtype	AREA WITH REDUCED FLOOD RISK DUE TO LEVEE
Flood Zone Study Type	NP

Distance From Location (approximate)	Location is within flood zone.
FEMA Risk Index - Coastal Flood Annualized Frequency	Very Low   Coastal flood data is not collected for this census tract. This normally indicates that the location is not at risk.
FEMA Risk Index - Riverine Flood Annualized Frequency	No data available   Riverine flood data is not collected for this census tract. This normally indicates that the location is not at risk.
FEMA Flood Map	<a href="https://msc.fema.gov/portal/search?AddressQuery=-121.58898664049184%2C%2039.14359391889265#searchresultsanchor">https://msc.fema.gov/portal/search?AddressQuery=-121.58898664049184%2C%2039.14359391889265#searchresultsanchor</a>

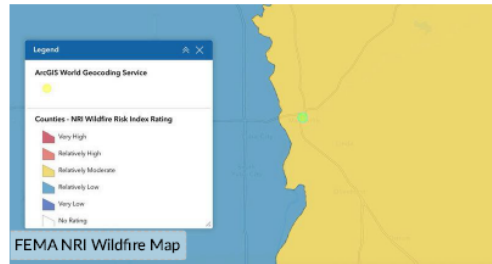
FEMA NRI Wildfire Map

<b>FEMA Risk Index - Wildfire Annualized Frequency</b>	Low   0.0020 events per year (census tract level)
<b>California?</b>	Yes
<b>California Fire Hazard Severity Zone</b>	Unmapped Zone or Federal Responsibility Area
